TITLE: Behavior of a Failed Fuel Rod During Film Boiling Operation

BEHAVIOR OF A FAILED FUEL ROD DURING FILM BOILING OPERATION
(PCM-1 Test in the PBF)

B. A. Cook, R. R. Hobbins*, and D. T. Sparks

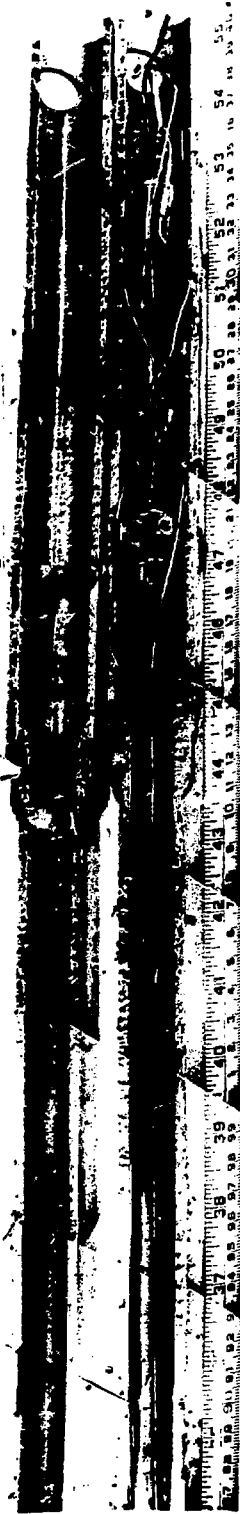
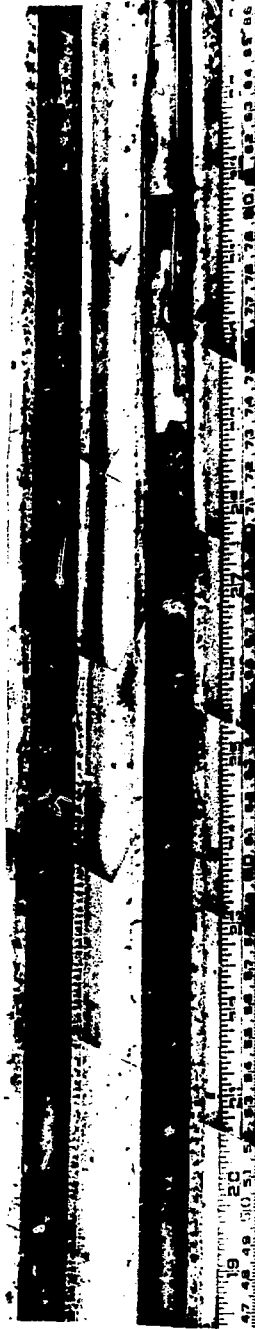
Fig. 1 Overall view of PCN-1 fuel rod in flow shroud.

Significant breakup of the fuel rod occurred during testing, as is shown in Figure 1. The initial failure mechanism was probably cladding embrittlement. At the average cladding temperature of 1800 K, embrittlement of the cladding by oxidation would have been expected when the β phase in the zircaloy was entirely consumed (24% ECR). This criterion was met at 580 seconds. Instrumentation gave indications of initial rod failure at 520 seconds. The initial failure location could not be determined due to the extensive chemical and mechanical interaction of the fuel rod components.

Additional rod fragmentation occurred at shutdown. Twenty-four percent of the fuel stack broke into pieces less than 76 μm in size and were swept from the flow shroud by the coolant flow. However, several unclad sections of the fuel stack, a maximum of 3 cm long, remained intact. Examination revealed the unclad fuel sections to have operated for some period of time in film boiling.

Evidence of cladding melting was observed over about 0.1 m of the fuel rod. The molten cladding was contained in an oxide shell in some locations long enough for the molten zircaloy to absorb oxygen and transform to solid ZrO_2 . The cladding was observed to be embrittled between the 0.30- and 0.68-m elevations. However, in this region, sections of fuel rod with completely embrittled cladding (all ZrO_2 or ZrO_2 and oxygen-stabilized alpha zircaloy) remained intact. In some locations the oxidized cladding was bonded to the fuel.

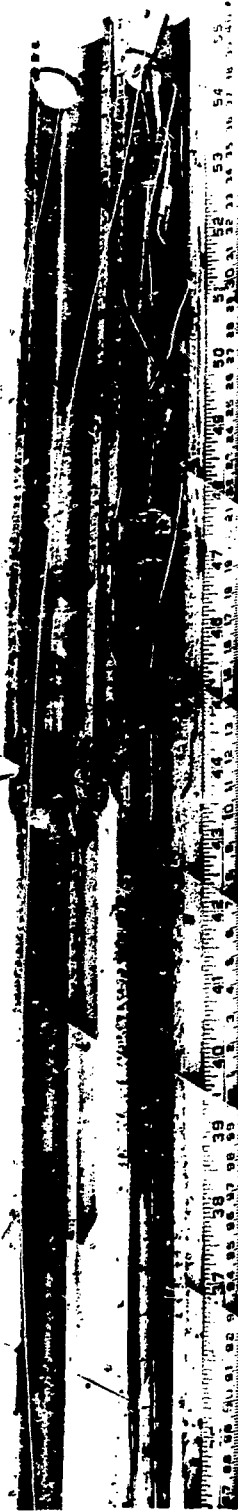
Fig. 1 Overall view of PCM-1 fuel rod in flow shroud.

Significant breakup of the fuel rod occurred during testing, as is shown in Figure 1. The initial failure mechanism was probably cladding embrittlement. At the average cladding temperature of 1800 K, embrittlement of the cladding by oxidation would have been expected when the β phase in the zircaloy was entirely consumed (24% ECR). This criterion was met at 580 seconds. Instrumentation gave indications of initial rod failure at 520 seconds. The initial failure location could not be determined due to the extensive chemical and mechanical interaction of the fuel rod components.

Additional rod fragmentation occurred at shutdown. Twenty-four percent of the fuel stack broke into pieces less than 76 μm in size and were swept from the flow shroud by the coolant flow. However, several unclad sections of the fuel stack, a maximum of 3 cm long, remained intact. Examination revealed the unclad fuel sections to have operated for some period of time in film boiling.

Evidence of cladding melting was observed over about 0.1 m of the fuel rod. The molten cladding was contained in an oxide shell in some locations long enough for the molten zircaloy to absorb oxygen and transform to solid ZrO_2 . The cladding was observed to be embrittled between the 0.30- and 0.68-m elevations. However, in this region, sections of fuel rod with completely embrittled cladding (all ZrO_2 or ZrO_2 and oxygen-stabilized alpha zircaloy) remained intact. In some locations the oxidized cladding was bonded to the fuel.
